**Investigation Report on the Accident to**

**Ethiopian 409 – Boeing 737-800**

**Registration ET-ANB**

**Presented by the IIC on 17<sup>th</sup> January 2012**

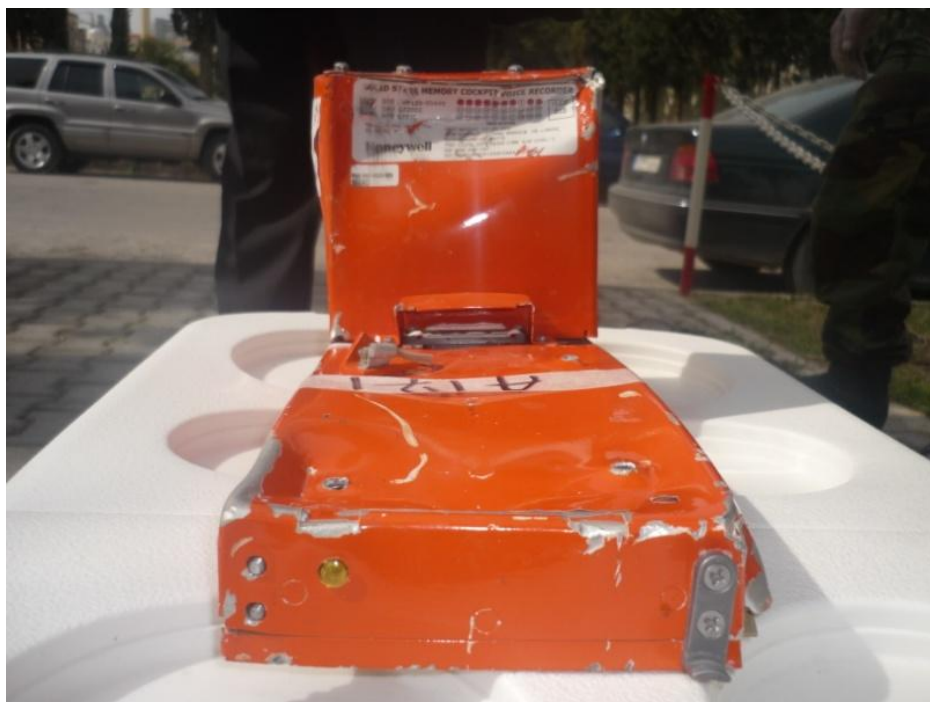
**Figure 4: CVR Chassis**

The CVR unit chassis exhibited external and internal structural damage with the CSMU detached from the chassis; the CSMU was in good condition. The opening, extraction of the double memory board from the CSMU and the read-out operations were performed following BEA procedures and Honeywell “*Reference Procedure for SSCVR Data Recovery after an*

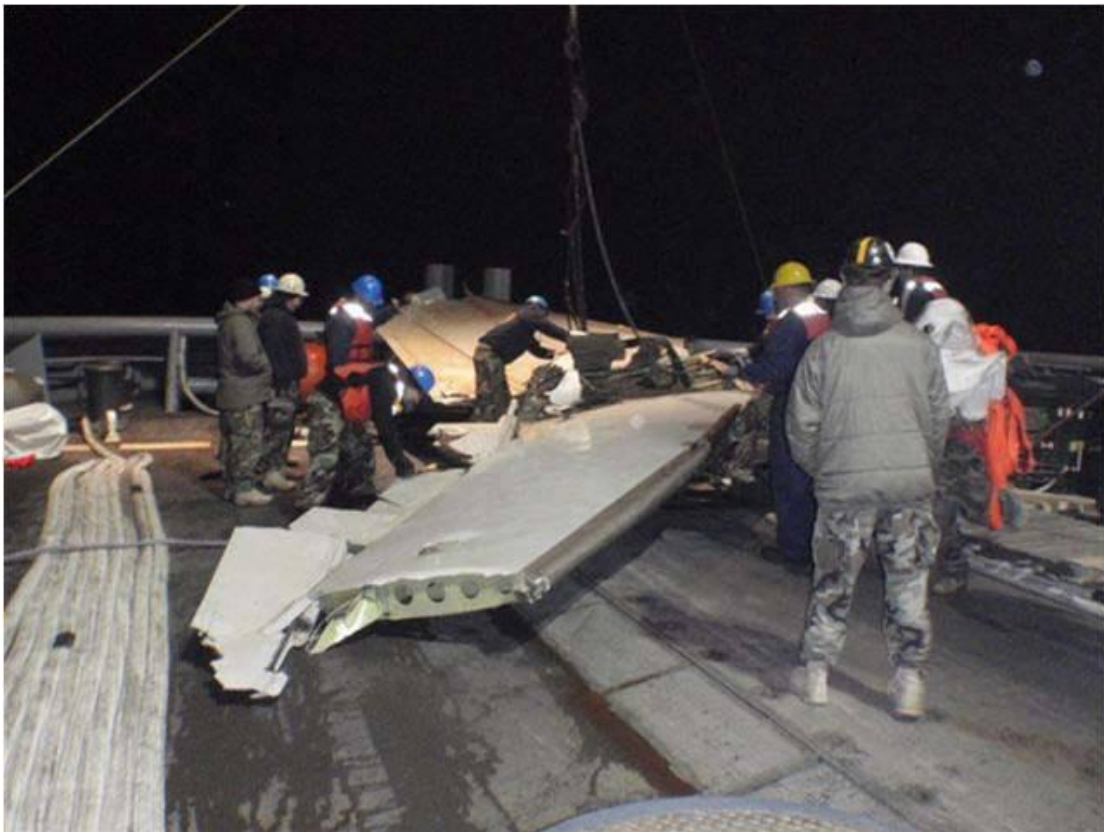
**Figure 9: Recovery of the Stabilizer Section**

The horizontal stabilizer section was recovered (during the search for the DFDR and CVR); this portion was relocated to Beirut Naval Station. The Airworthiness Group has recommended the removal of the Trim Tab section and sending it to the NTSB for further investigation. That recommendation was approved by the IC and the Trim Tab analysis is discussed in section 1.16 of this report with the full report attached as Appendix O.

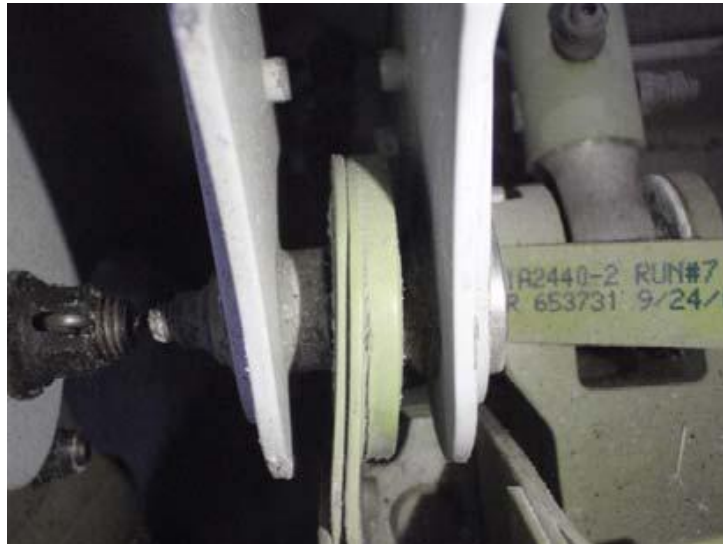
**Figure 13: Left Outboard Lugs & Spacer**

On the accident aircraft, both sides of the horizontal stabilizer were accessed and the inspections revealed no discrepancies for the inspected components. The spacers were tight and could not be rotated by hand pressure. Although a feeler gage was not available, there were no observed gaps in between the lugs or the lug and the spacer. A fingernail could not be inserted between the pieces inspected.

The inspection also noted that the left mechanism inboard attach point could be displaced 0.25 inches laterally and vertically using hand force and that the inner race of the bearing appears to be damaged. However, the tab hinges (three hinges on the right tab; all hinges on the left tab), tab rods and their connections were inspected and found to have all hardware present. All hinge points move freely and without noticeable play or looseness.

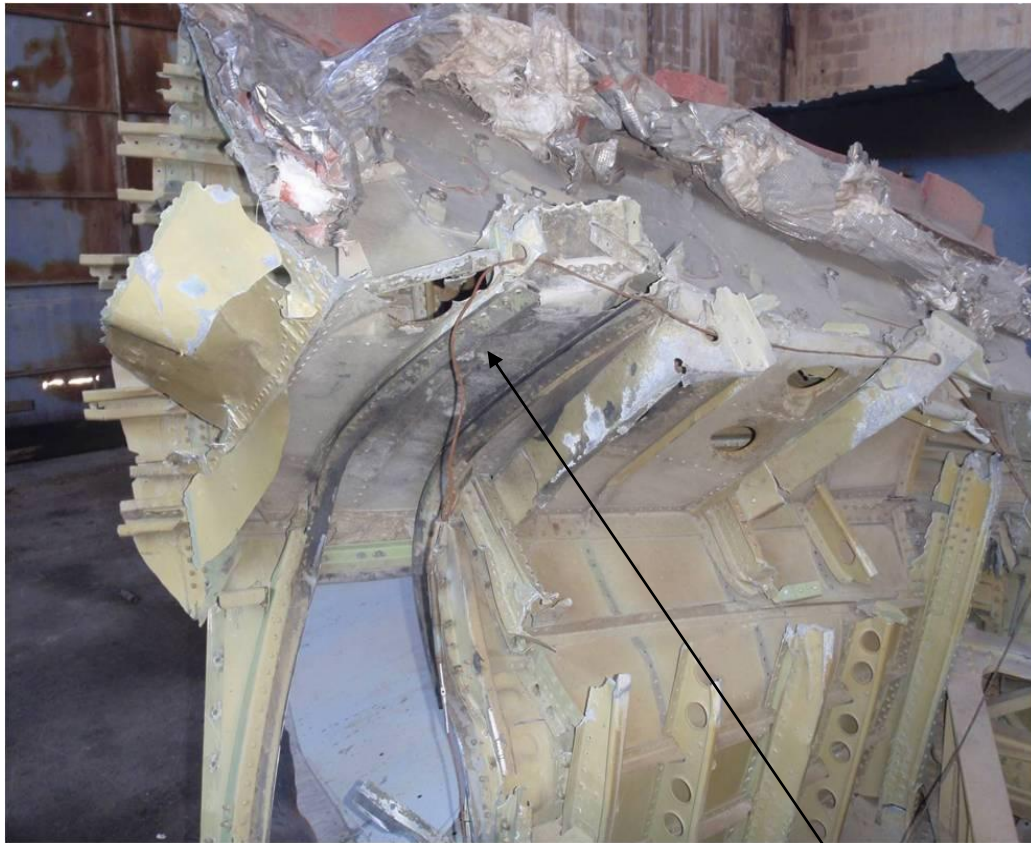
**Figure 14: The APU Exhaust area showing the Black Soot**

The NTSB report was received from the US Accredited Representative on July 29, 2011. The report specified that “*There was no discoloration to the primer paint and the surface was uniformly covered with a light coating of sand or dirt. Zinc chromate primer paint changes color when exposed to heat.*” It goes to conclude that “*Since there was no change in the color of the paint on the primer side, there was no indication that this section of fuselage was exposed to heat/high temperatures.*”

As for the origin of the black soot it determines after examining the material associated with the black soot that *“The spectrum obtained from the submitted unknown sample suggests that the material was organic as evidenced by the presence of characteristic carbon-hydrogen bonding peaks between ~3000 cm-1 and ~2800 cm-1 as well as a small group of peaks between 2300 and 1400 cm-1. This peak configuration is indicative of a straight chained, aliphatic hydrocarbon. When compared to the spectra of known materials, the unknown material most closely matched spectra from lubricating oils.”*

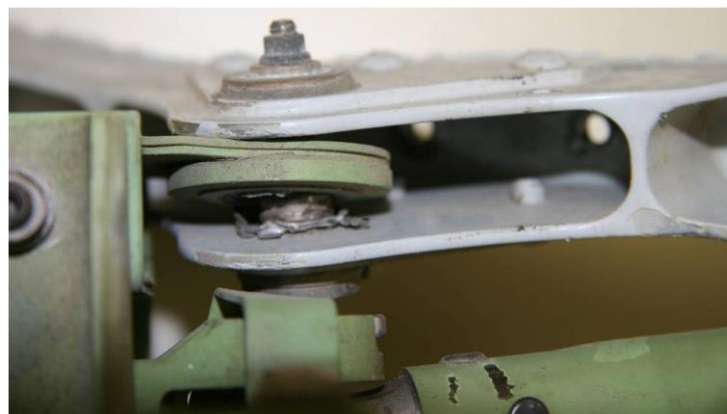
**Figure 17: Left Inner Attachment Bearing**

A few months after the accident, the FAA issued an AD not related to that accident requiring a periodic on-going inspection of the bearing retention for a secure swage on all Boeing NG airplanes. Therefore, the IC decided to send the trim tab mechanism to the NTSB for analysis, especially that inboard attach bearing of the left side tab mechanism was found with all of the bearing balls missing. Refer to Figure 17 below.

The reason behind issuing the AD was two reports of unusual airframe vibration involving Boeing 737 NG airplanes. Despite airframe vibration, neither airplane suffered from “loss of integrity” to their flight control systems; both airplanes continued safe flight and landings. Post flight examination of both airplanes revealed that the elevator tab mechanism on one side had become completely detached (both inboard and outboard lugs) from its mountings on the front spar of the elevator. Analysis attributed these fractures to the loss of the attach point bearing retention and subsequent fracture of the attach tab. However, the DFDR of the two airplanes that diverted as a result of the vibration oscillation triggering the issue of the AD showed significant oscillatory movement of the elevator following its final fracture.

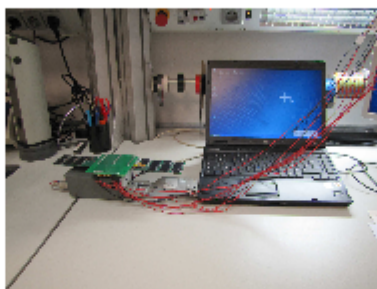
The CVR boards were connected to the BEA memory reader and each memory chip was individually selected and read out. All the memory chips were correctly read out except U16 (also referred as CE#19 memory chip in Honeywell documentation) which could not be read out at all. The read-out data was saved.

*CVR boards connected to BEA memory reader*

The assumption based on the visual inspection performed in February 17<sup>th</sup>, 2010 is confirmed: U16, the memory chip with the crack, is the non-functioning memory chip.
